BRISTOL COUNTY WATER AUTHORITY 2019 PVC SLIPLINING OF THE EAST BAY PIPELINE OF THE EAST BAY PIPELINE

By: Paul Smith, P.E., BETA Group, Inc.
Michael Crawford, P.E., Bristol County Water Authority

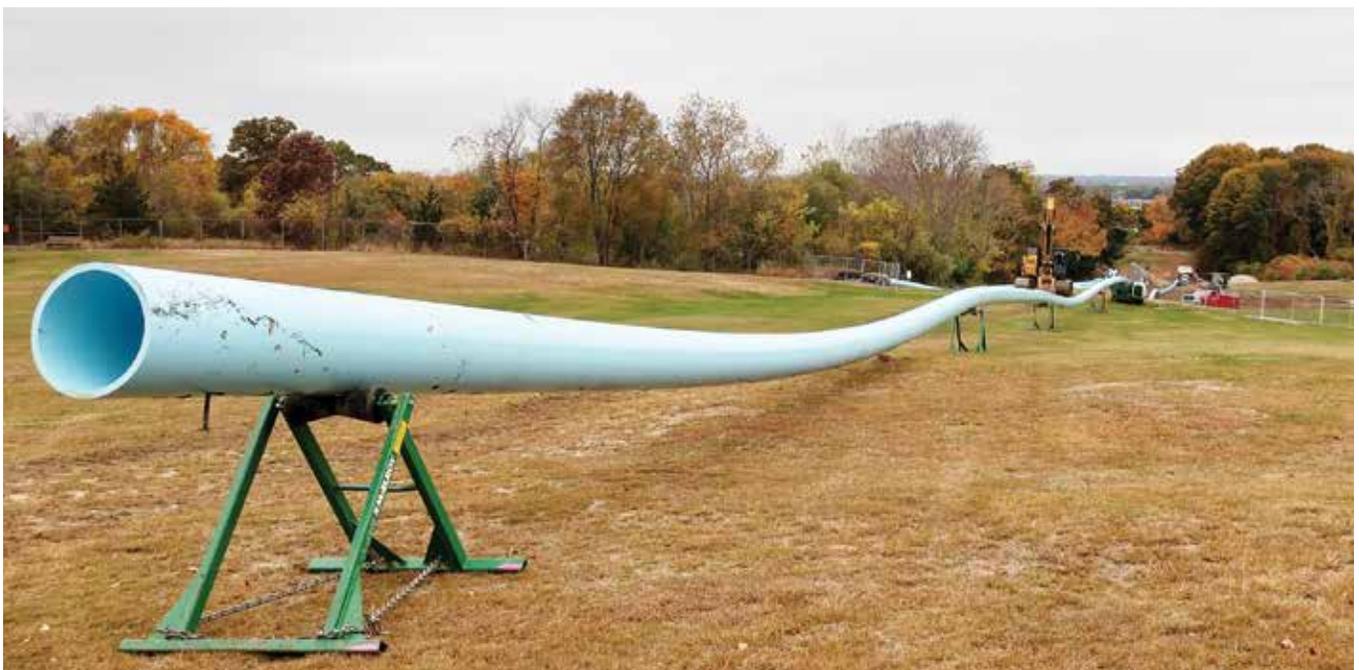
PVC was fused into 450-foot lengths, 10 sections of pipe in total
